INDIVIDUAL PROPERTY/DISTRICT
MARYLAND HISTORICAL TRUST
INTERNAL NR-ELIGIBILITY REVIEW FORM

Property/District Name: Meadow Brook Farm Survey Number: CARR- 391
Project: Westminster Bypass (MD 140) Agency: SHA
Site visit by MHT Staff: X no yes Name Date
Eligibility recommended X Eligibility not recommended
Criteria: A XB XC D Considerations: A B C D E F G None
Justification for decision: (Use continuation sheet if necessary and attach map)
This property was determined eligible for the NR by MHT letter dated 4/27/1994.

historic Meadow Brook Farm (preferred)

Continuation sheet Meadow Brook Farm Item number 7 Page 1
Carroll County, Maryland

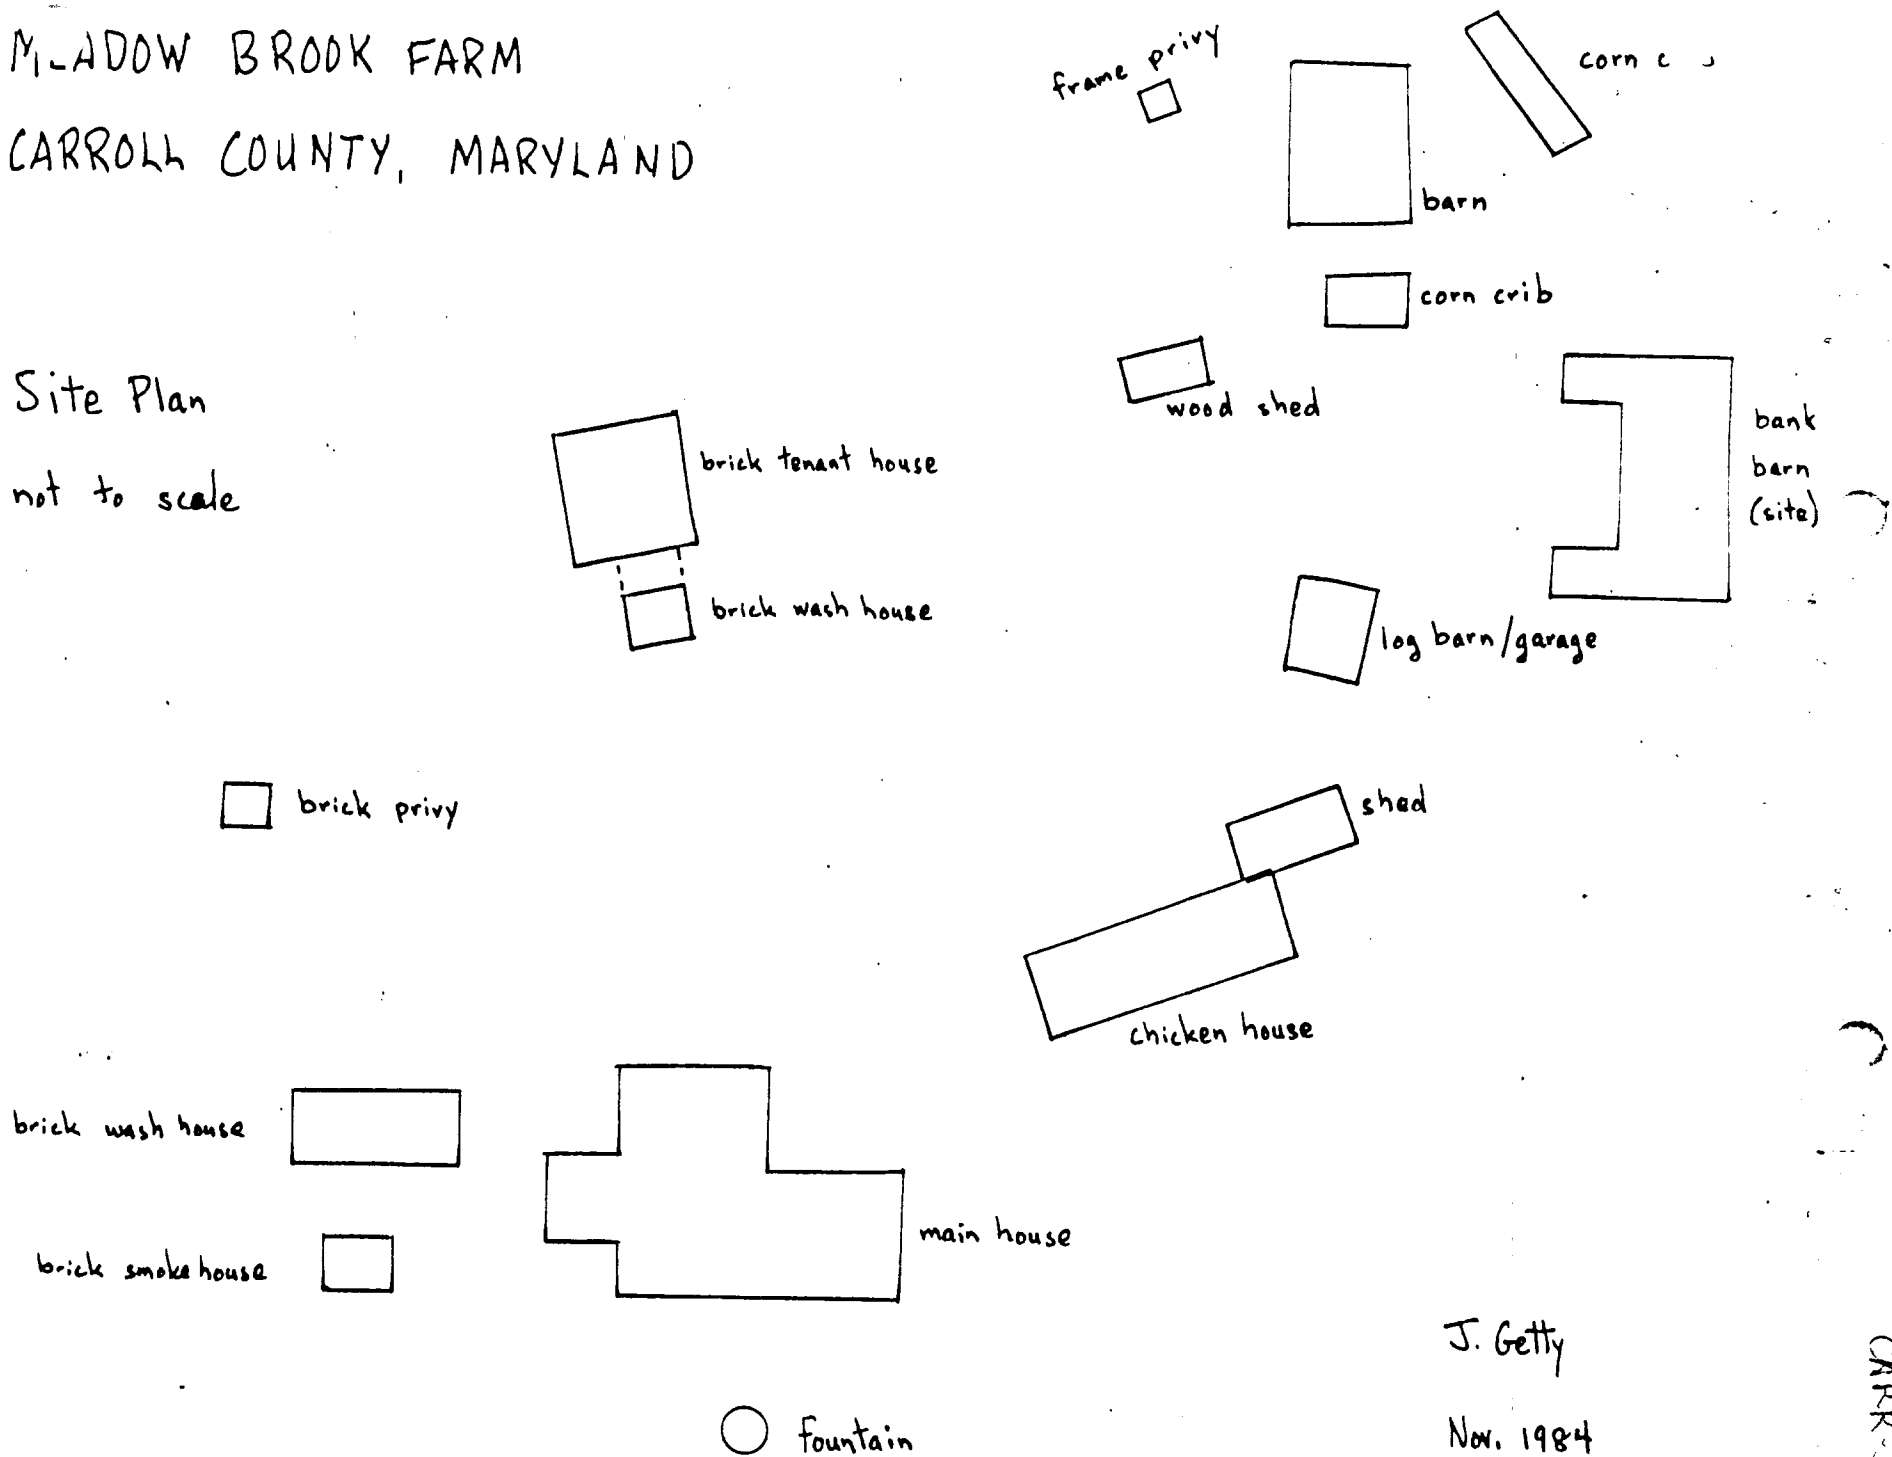
Site Plan
not to scale

Meadow Brook Farm
CARROLL COUNTY, MARYLAND

The property includes several significant outbuildings. On the west side of the main house is a row of outbuildings that includes a smokehouse, washhouse and privy. The smokehouse is a square-shaped brick structure with a hipped roof. Its entrance is on the east side of the structure where it has a batten door and hasp. The other three facades are unfenestrated but have a single slit opening. Inside the smokehouse is a small brick firestand and a central revolving post with arms which could be described as a "meat tree."

To the north of the main house is a two-story, three-bay by two-bay brick tenant house. It is constructed of common bond brick on a stone foundation. The main facade has a central entrance with a one-story, one-bay wide porch with Victorian style wood trim. The other bays contain six-over-six sash windows with brick jack-arch lintels. The structure has a gable roof covered in sheet-metal and interior-end brick chimneys at each gable end. While the structure appears to have a rectangular plan, it originally was L-shaped with the section at the southeast corner that is now framed in wood having originally been a double-tiered porch. The interior has a three-room plan with two rooms on the north side and a single room that has been enlarged with the enclosed porch area on the south. The entrance opens into the northwest room; there is an enclosed staircase in the south room. An unusual feature of the house is the reused hardware and early doors, especially those found on the second story interior doorways. From its construction details, the date of build appears to be late nineteenth century and the reused materials may originate from the main house assuming that this house was built in the 1870s when the main house was being remodeled.

A brick washhouse is located just south of the gable end of the tenant house and the two are connected by a gable roof that allows a sheltered passage from the cold-cellar basement to the washhouse. The south gable end of the washhouse contains the large fireplace that retains its large iron crane. Outbuildings located east of the tenant house depict the evolution of an agricultural complex during the nineteenth century. A frame privy and frame woodshed are located close to the tenant house. Farm buildings include a log barn now covered in board-and-batten and converted to a garage, a medium-sized barn and stable and the foundation of the large bank barn. Near the barns are two corn cribs: one has a rectangular plan with a gable roof; the other has a long rectangular plan with a shed roof. Between the barns and the main house is a board-and-batten carriage house and a long shed that included a chicken house and tool storage areas. The large frame bank barn was destroyed by a fire during the 1970s. However, a photograph taken during the 1930s by the Historic American Buildings Survey shows the barn as it appeared at that time.

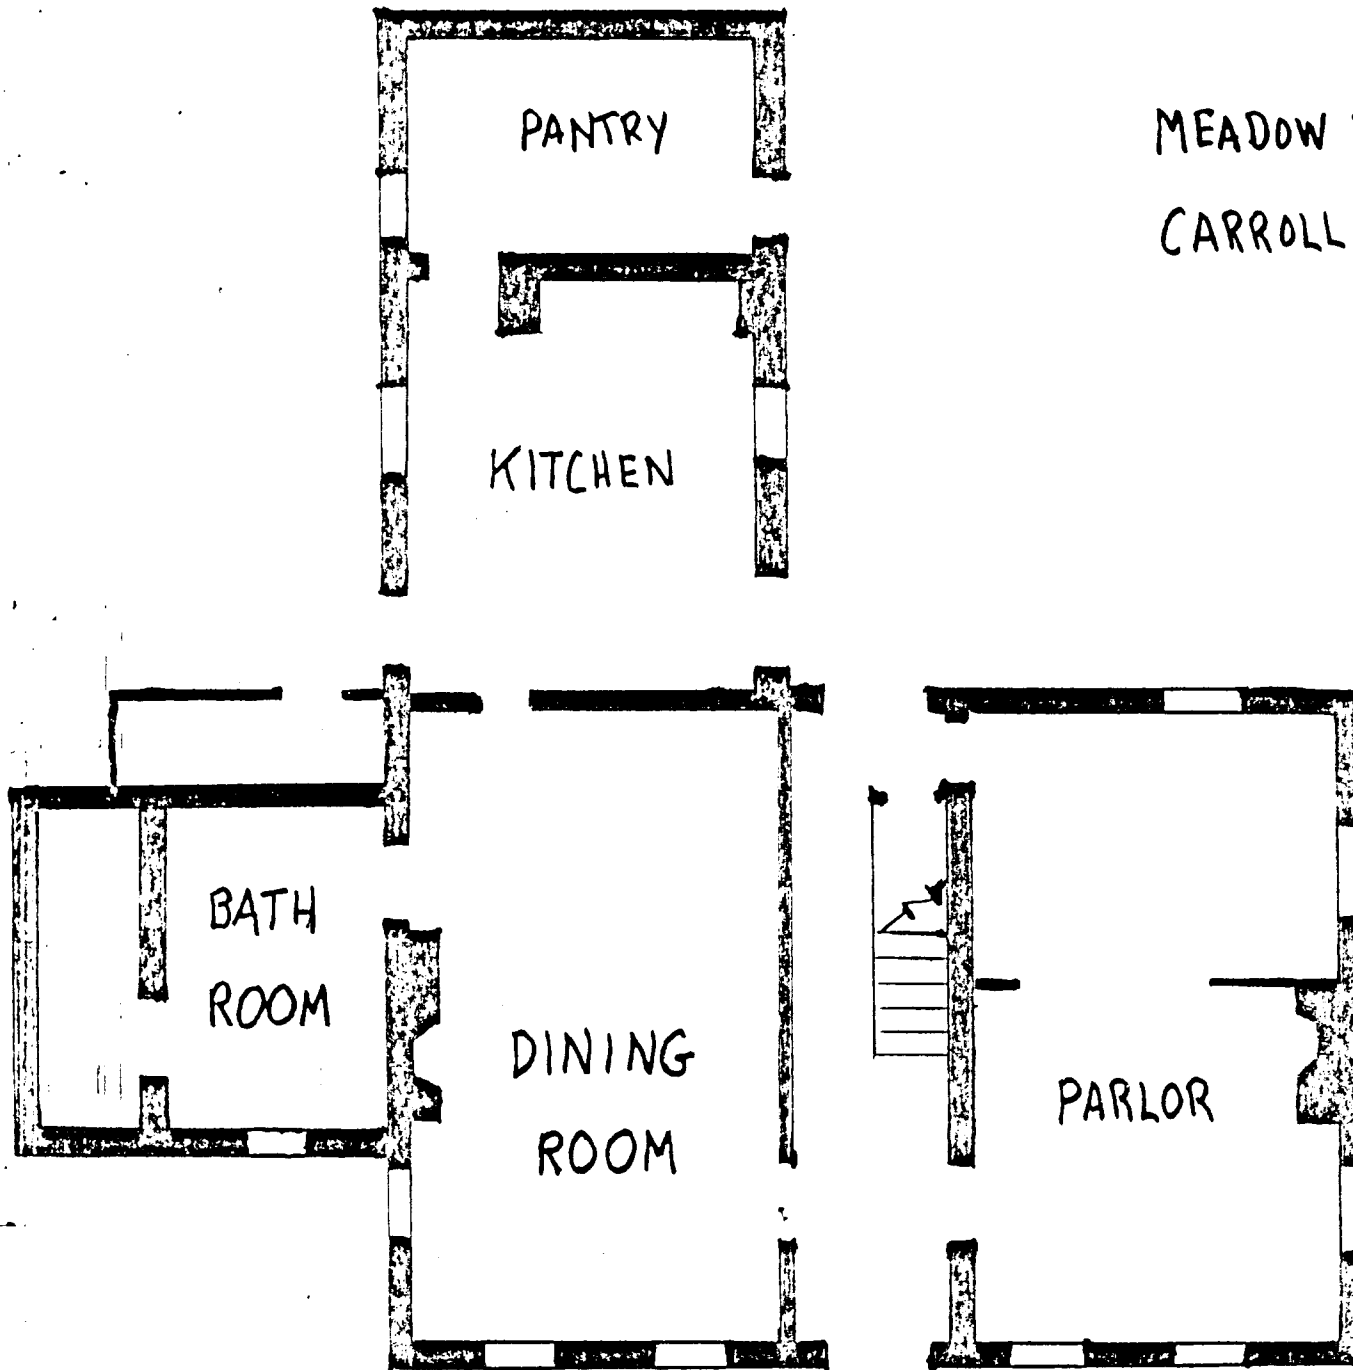
First Floor Plan
Not to Scale

MEADOW BROOK FARM
CARROLL COUNTY, MARYLAND

The interior of the house contains a central stair hall with a three-room arrangement of the L-shaped plan. There is a parlor on the east side of the stair hall, a dining room on the west side of the stair hall, and a kitchen in the ell. The two additions, the bathhouse on the west side of the dining room and the pantry at the rear of the ell, provide service uses to the main house. The interior

ornamentation consists of a combination of features from the original construction of the house and from the Victorian period remodeling. This can be viewed right away in the stair hall where there is an original peg rail on the west partition wall. The peg rail contains a beaded upper and lower edge and hand-shaped pegs. The main feature of the stair hall is the staircase which rises on the east partition wall and which has a Victorian-style railing, newel post, and ballusters. The original railing and ballusters are stored in the attic of the house.

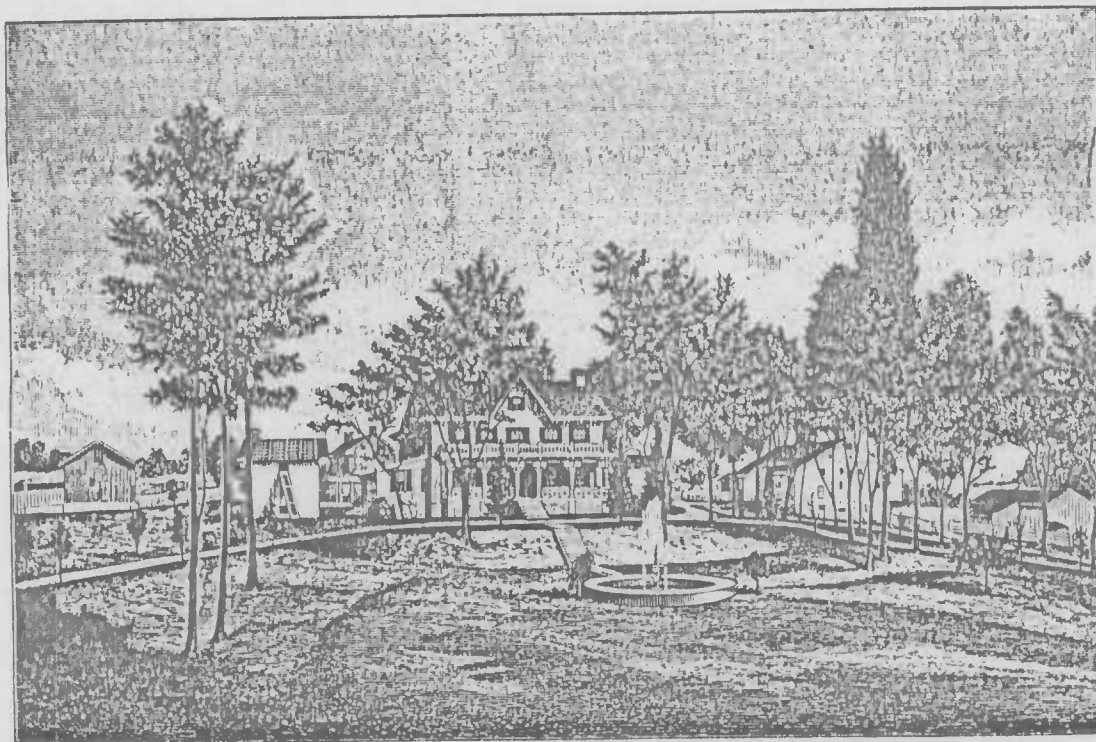
RESIDENCE OF SAMUEL ROOP, WESTMINSTER, CARROLL CO., MD.

Illustration of MEADOW BROOK FARM, CARR-391

from: J. Thomas Scharf, History of Western Maryland, p. 892

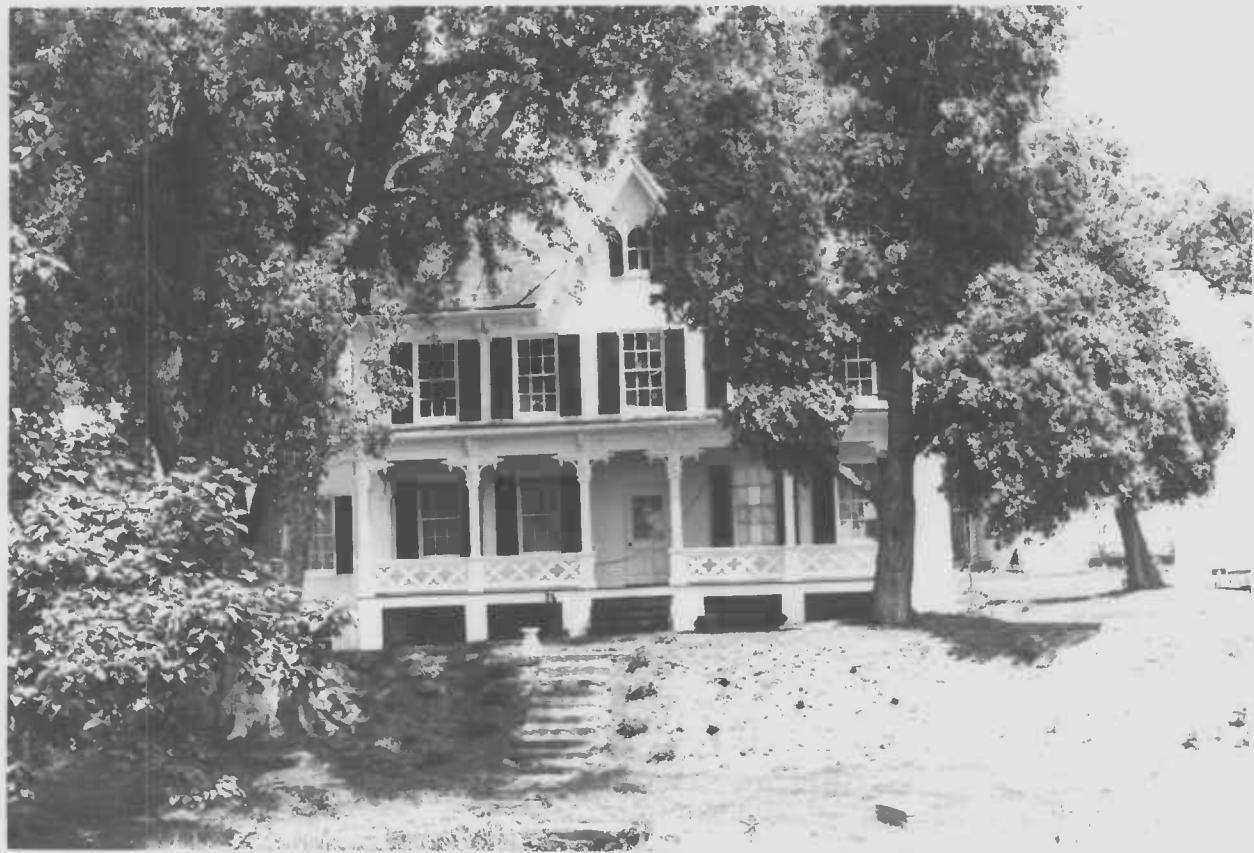
1. CARR-391 SAMUEL ROOP FARM
2. Carroll County, Maryland
3. Joe Getty
4. August 1983 (*Meadow Brook Farm*)
5. Md. Historical Trust, Annapolis, Md.
6. West elevation (camera facing east)
7. 1/1
